SIO Shipyard Representative Bi-Weekly Progress Report		
Project: AGOR 28	Contract No.: N00014-12-C-0305	Shipyard: Dakota Creek Industries
Prepared by: Paul D. Bueren Scripps Institution of Oceanography (SIO) 297 Rosecrans St. San Diego, CA 98106	Date: 1 March 2016	Program Officer: Robert (Tim) Schnoor Office of Naval Research 875 Randolph St ONR 321 Arlington, VA 22203-1995
Distribution Statement A: Approved for public release; distribution unlimited.		Report No. A002.095

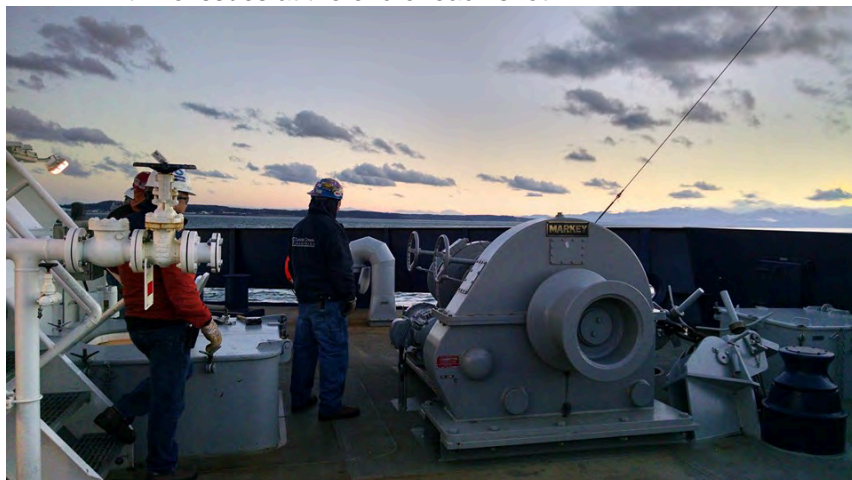
- **Starboard Drive Failure** – The drive has been fully tested under full load with no issue to report. A new DC breaker is to be installed and the current breaker will be place into spares. PME 325 is exploring options to add a spare AIM, ALM and Motor Drive Module to the shore based spares.
- **Ballast Tank Coatings** – Monitoring GDR's for coating issues on Armstrong. WTA for pre delivery ballast tank inspection on Ride is in the works.
- **Anchor Windlass** – Mock INSURV anchor demo was performed with good results. One shot of chain was walked out, port and starboard, with no skipping. The chain did skip multiple times on both sides with the wildcat declutched and in free fall. The chain stopped using the hand brake with no issues at the end of each shot.

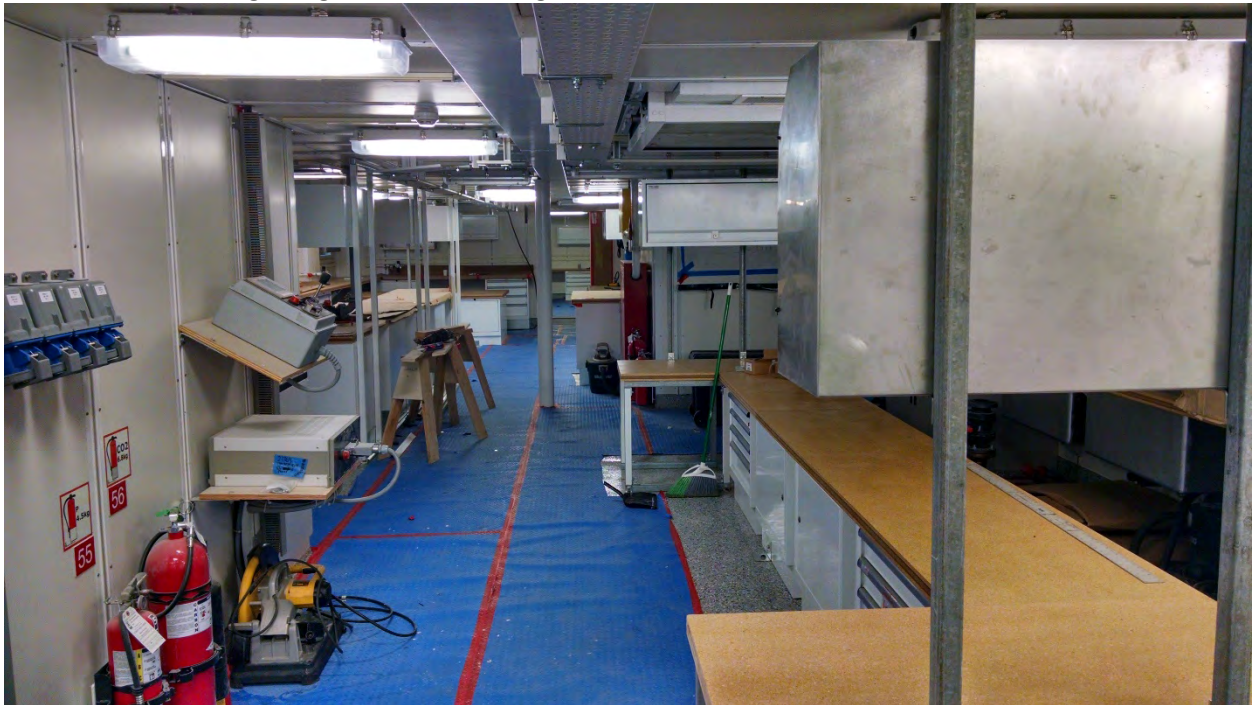
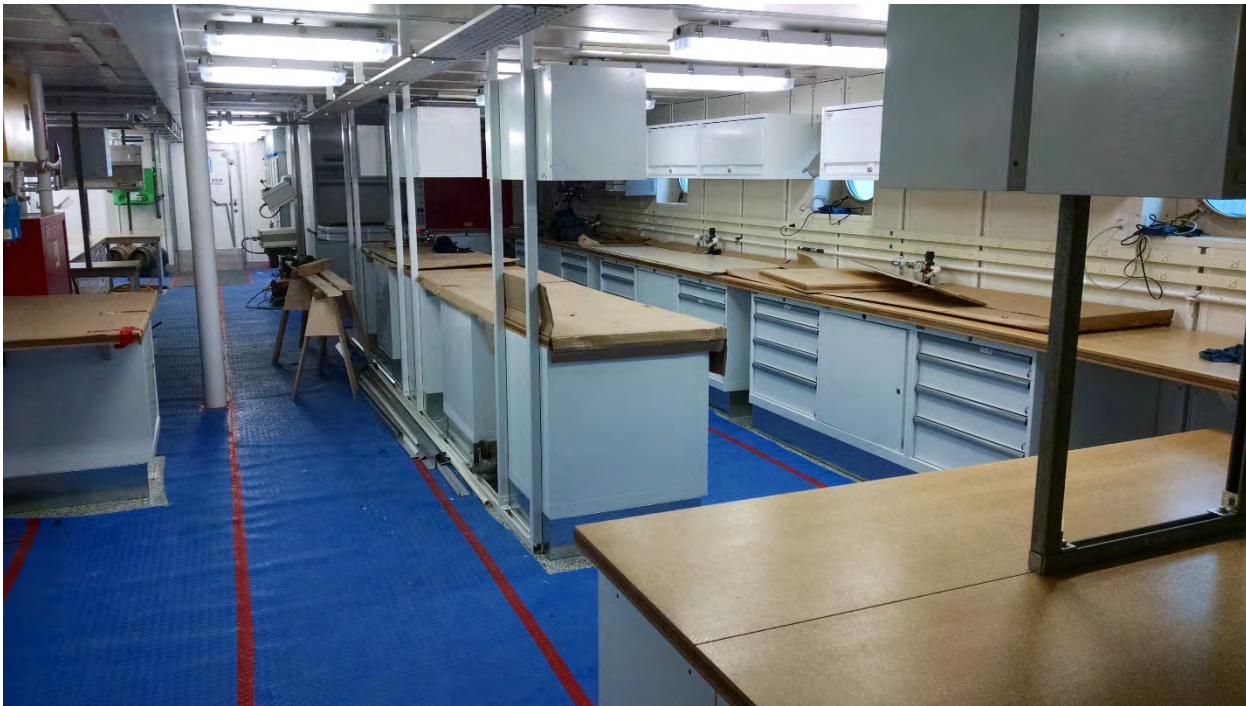
Work continues in Labs, getting closer to finishing
